DEPARTMENT OF TRANSPORTATION**DIVISION OF ENGINEERING SERVICES**

Contract #: 04-0120F4Cty: SF/ALA Rte: 80 PM: 13.2/13.9File #: 69.28**WELDING INSPECTION REPORT****Resident Engineer:**Siegenthaler, Peter**Address:** 333 Burma Road**City:** Oakland, CA 94607**Report No:** WIR-021315**Date Inspected:** 28-Feb-2011**Project Name:** SAS Superstructure**OSM Arrival Time:** 700**Prime Contractor:** American Bridge/Fluor Enterprises, a JV**OSM Departure Time:** 1900**Contractor:** Zhenhua Port Machinery Company, Ltd (ZPMC), Changxing Island **Location:** Shanghai, China**CWI Name:** Zho Zhong Hai**CWI Present:** Yes No**Inspected CWI report:** Yes No N/A**Rod Oven in Use:** Yes No N/A**Electrode to specification:** Yes No N/A**Weld Procedures Followed:** Yes No N/A**Qualified Welders:** Yes No N/A**Verified Joint Fit-up:** Yes No N/A**Approved Drawings:** Yes No N/A**Approved WPS:** Yes No N/A**Delayed / Cancelled:** Yes No N/A**Bridge No:** 34-0006**Component:** Orthotropic Box Girder(OBG)**Summary of Items Observed:**

OBG # TRIAL ASSEMBLY YARD**WELDING:**

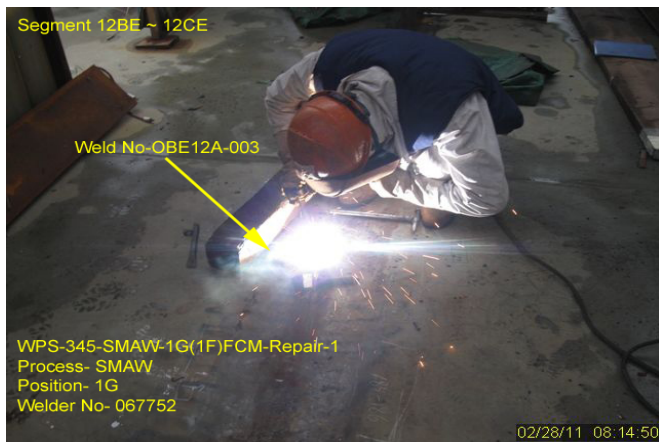
This QA Inspector observed ZPMC qualified welding personnel identified as 067752 perform Shielded Metal Arc Welding (SMAW), weld joint identified as OBE12A-003; located On Orthotropic Box Girder (OBG) Deck Plate to Deck Plate CJP Weld; ZPMC Quality Control (QC) is identified as Mr. Wang Li Yang. This QA Inspector observed a welding current of approximately 178 amps and 23.8 volts and the base material appears to have been being preheated by an electrical heating elements prior to welding The Critical Welding Repair Report (CWRR) was B-CWR2813 Rev-1 .This QA Inspector observed the base material appears to have been preheated by an electrical heating element prior to welding. ZPMC Quality Control (QC) Mr. Wang Li Yang was onsite monitoring the welding variables. The welding variables recorded by QC appeared to comply with applicable WPS-345-SMAW-1G (1F) FCM-Repair-1. See attached photo for further details.

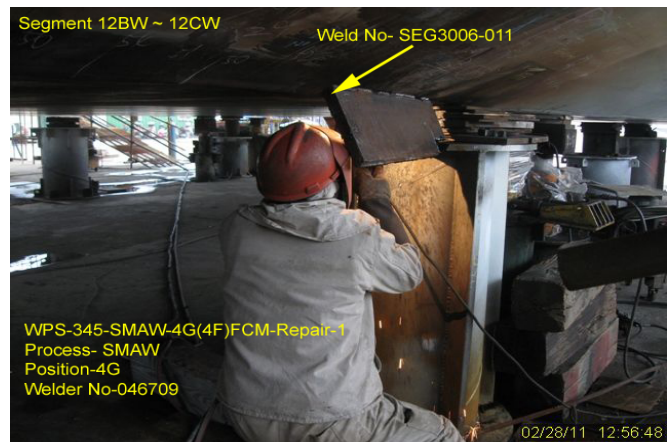
This QA Inspector observed ZPMC qualified welding personnel identified as 046709 perform Shielded Metal Arc Welding (SMAW), weld joint identified as SEG3006-011; located On Orthotropic Box Girder (OBG) Bottom Plate to Side Plate CJP Weld; ZPMC Quality Control (QC) is identified as Mr. Zhou Peng. This QA Inspector observed a welding current of approximately 164 amps and 24.6 volts and the base material appears to have been preheated by an electrical heating elements prior to welding The Welding Repair Report (WRR) was B-WR19624 . This QA Inspector observed the base material appears to have been being preheated by an electrical heating element prior to welding. ZPMC Quality Control (QC) Mr. Zhou Peng was onsite monitoring the welding variables. The welding variables recorded by QC appeared to comply with applicable WPS-345-SMAW-4G (4F) FCM-Repair-1. See attached photo for further details.
